CARTRIDGE/STYLUS INSPECTION REPORT No. A0017

<b>CUSTOMER:</b>	Peter Stirling	<b>SERIAL NUMBER:</b>	N/A
<b>MAKE:</b>	Ortofon	<b>SYLUS PROFILE:</b>	Nude Shibata
<b>MODEL:</b>	Cadenza Black	<b>CANTILEVER:</b>	Boron cantilever
<b>CARTRIDGE TYPE:</b>	Moving Coil	<b>MAGNIFICATION:</b>	100 X
<b>MICROSCOPE:</b>	Leica MZ6	<b>CAMERA:</b>	Canon DSLR

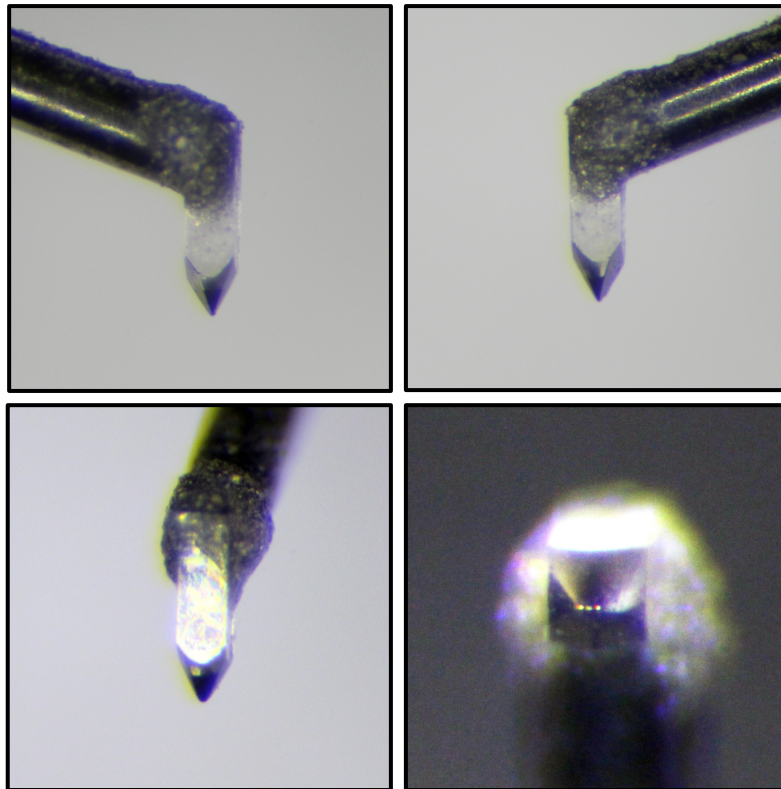
- NOTES:** The customer reported only around 100 hours use but requested an inspection of the stylus as he was concerned he may have damaged the stylus by dropping it rather heavily onto a record.
- CANTILEVER/DAMPING:** The cantilever is in good condition with no signs of damage it is straight and positioned at the correct angle in the cartridge body.
- STYLUS:** The styus is in good condition with no signs of damage. When the oblique lighting technique is used to view the "wear cats eyes" these presented as small round areas consitent with low use as opposed to the larger eliptical areas that indicate a higher degree of wear.
- SUMMARY/  
RECOMMENDATIONS:** The stylus, cantilever and cartridge are all in good condition and typical of a low use cartridge. Recommend checking again at approx 1000 hours use.
